## TECH TIP COOLING SYSTEM

### BULLETIN TT006-16

### Automotive Sealant Use During Water Pump Replacement

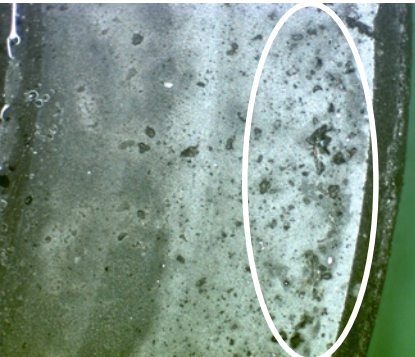
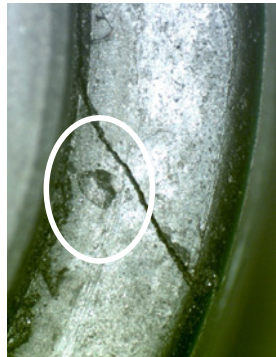
To the left are examples of Dynamic and Static seal contamination / filming caused by over use of sealants. When sealant particulates / residue get trapped between the Dynamic and Static seal faces it causes a separation of the two surfaces which leads to a seal leak.
