CASE STUDY:

TPU BELTS THERMOPLASTIC POLYURETHANE

Meat processing plant saves thousands of dollars in operating costs by replacing plastic modular belt with POSICLEAN™ PC20.

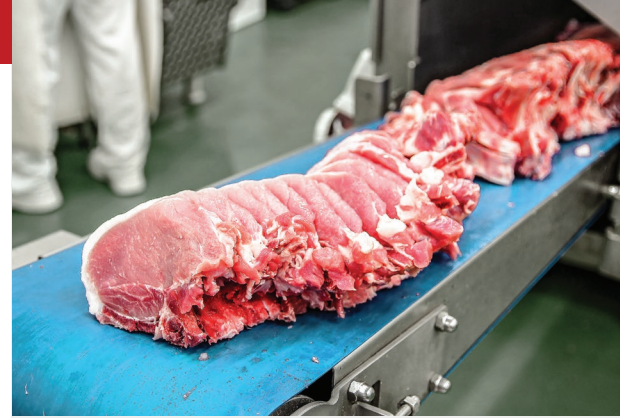
- The existing plastic modular belting was replaced with GATES® TPU POSICLEAN™ PC20 belt, an easy-to-clean, 2” pitch, positive drive replacement for plastic modular belting.
